A synthesis on the evolution of the studded tire.

**A Synthesis on the
Evolution of the Studded Tire**

Master of Science in Civil Engineering

University of Washington

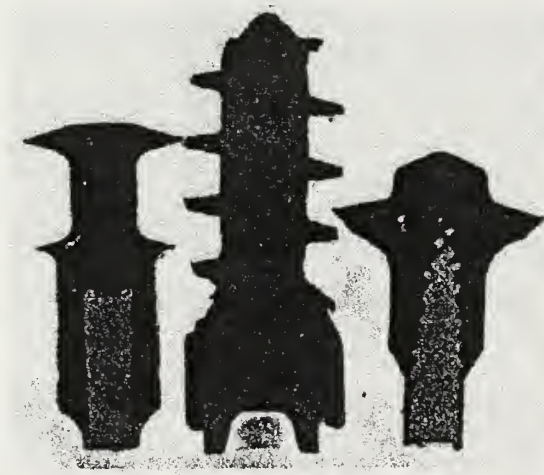
FIGURE 1. First tire studs with tungsten carbide cores [8].

The European and Scandinavian countries have been given credit for the initial market exposure of the tire stud to the driving public, which occurred in the late 1950's. The core of the first tire studs consisted of a small piece of tungsten carbide, which was about the thickness of a ten-penny nail (0.128 inches (3.2 mm)), had a length of approximately 0.313 inches (7.8 mm), and was held in place with a “jacket.” As a unit, it was referred to as a “winter tire stud” [35]. Figure 1 represents the basic design of the first tire studs with tungsten carbide cores [8].

Until the use of tungsten carbide as the core material, all previous attempts to develop anti-skid devices were unsuccessful. The success of the tungsten carbide core is the result of it being one of the hardest man-made materials available at that time. When manufactured to the proper specifications, and under normal driving conditions, it closely matched the wear rate of the rubber tire tread [35].
